INE MOULAERT AND WOUTER SCHIETTECATTE

DREDGING IN NEW CALEDONIA AT A UNESCO-IUCN WORLD HERITAGE SITE WITH CARE FOR NATURE

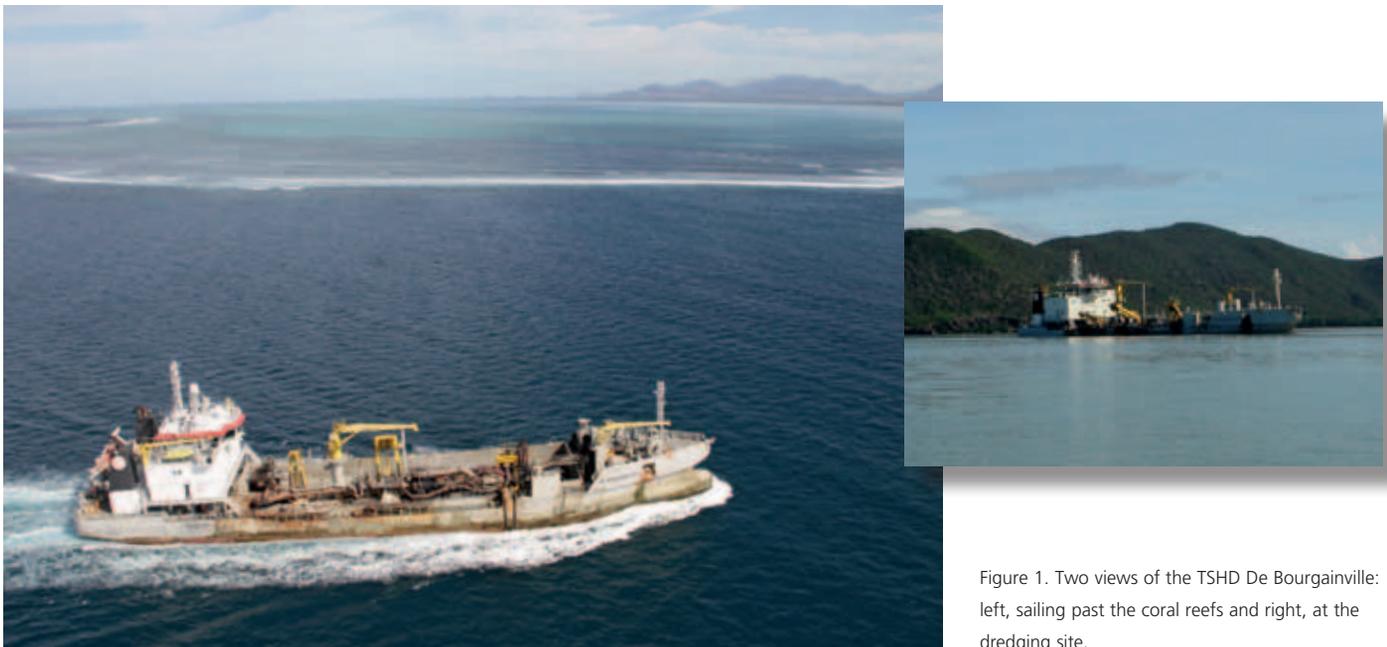
Figure 1. Two views of the TSHD De Bourgainville: left, sailing past the coral reefs and right, at the dredging site.

The TSHD *Le Bougainville*, the backhoe dredge BHD *Mimar Sinan* and several split-hopper barges (*Concepción*, *L'Etoile*, *Le Sphinx* and *Le Guerrier*) were involved in the dredging of a 4,500 m long navigation channel and turning basin, to a design depth of -12.0 m CD. The dredging and disposal areas were surrounded by vulnerable ecosystems like coral reefs and seagrass meadows (Figure 1).

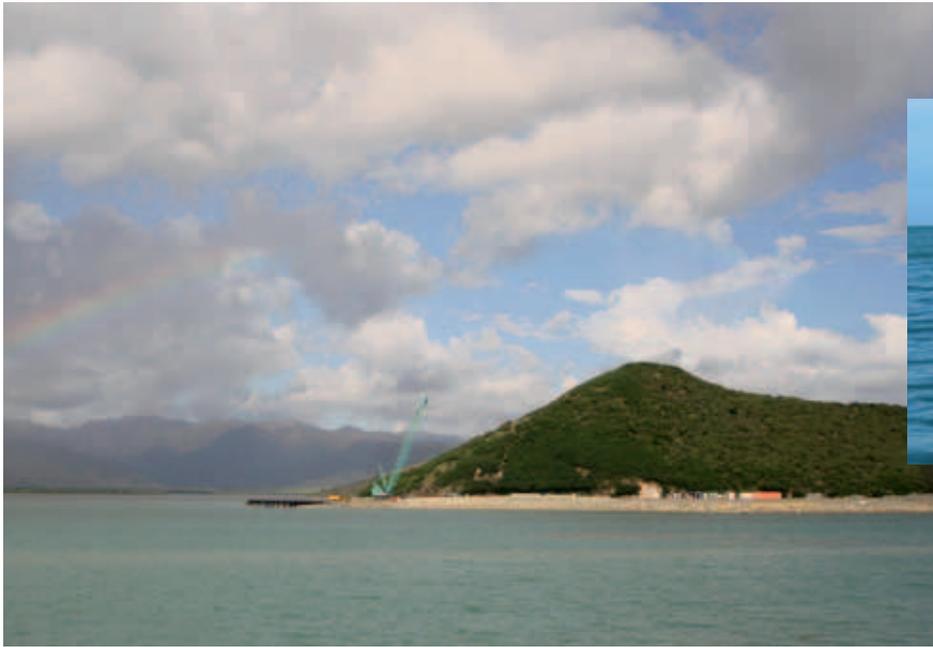
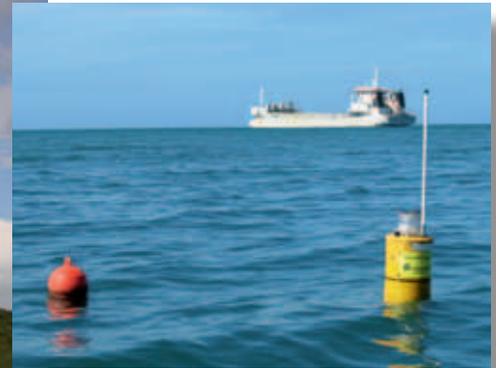
Figure 6. Left, the construction of the new port facility at New Caledonia. Above, Telemetry buoy anchored near the working area.

In order to check compliance with the thresholds outlined in the EMP and ensure continuous monitoring, telemetry buoys were used at most of the action sites. These telemetry buoys (Figure 6) were equipped with a multi-parameter probe. On site verifications, calibrations and maintenance were conducted regularly to ensure reliable measurements and proper functioning of the equipment.

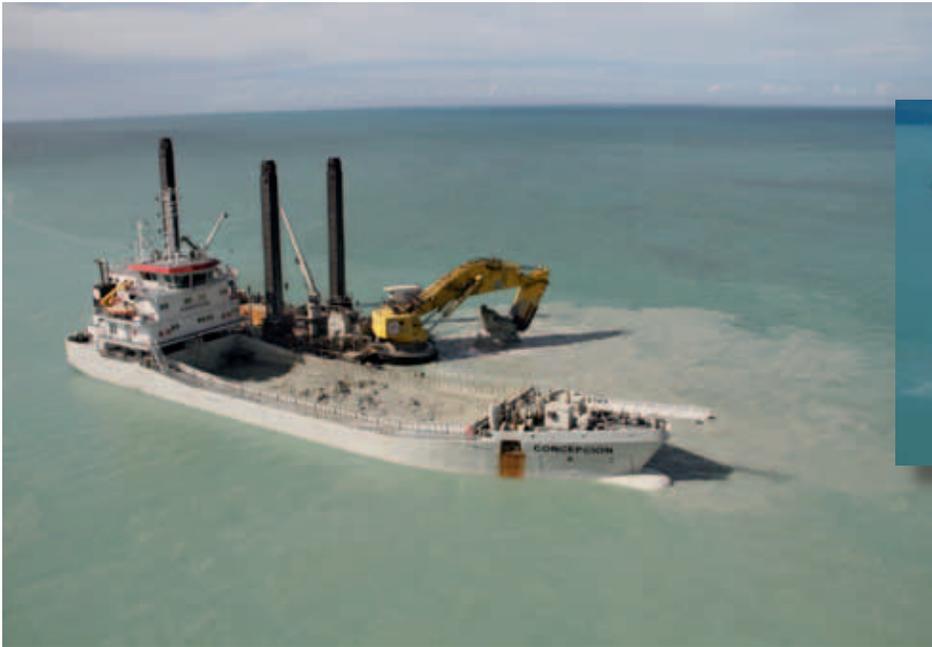
Figure 8. Above, turbidity plume created during dredging by the TSHD De Bougainville.

Dredging by the TSHD without overflow resulted in sediment plumes of 100-150 m wide, with peak turbidity values above 100 NTU just after passage of the TSHD, decreasing to maximum values of 40-50 NTU after 10 minutes. Turbidity further decreased at a rate depending on particle size. Dredging by the TSHD with overflow (during 5 minutes) resulted in a similar plume width (150 m), but turbidity values were higher, especially during the first 15 minutes after dredging.

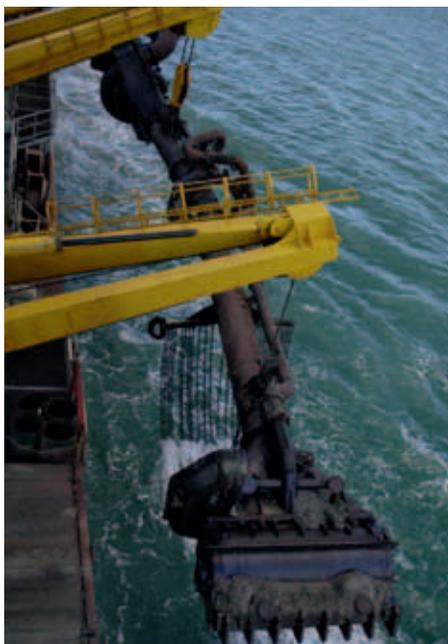
Figure 10. Turtle deflector installed on the drag head of the TSHD.
