Elijah Ohimain

# Environmental Impacts of Dredging in the Niger Delta

## Options for sediment relocation that will mitigate acidification and enhance natural mangrove restoration

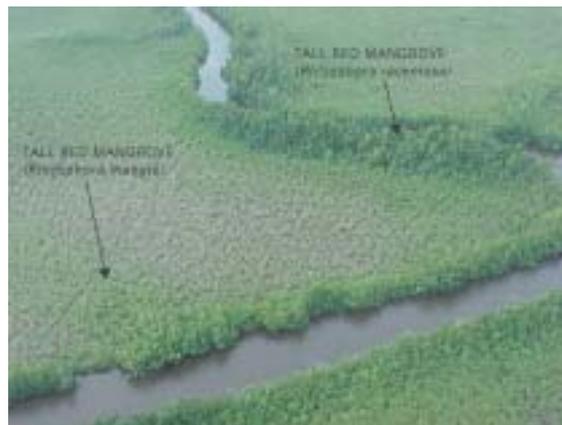
Figure 3. Mangroves in the Niger Delta are environmentally sensitive and fragile. Shown here are tall red mangrove (*rhizophora racemosa*) and dwarf red mangrove (*rhizophora mangle*).

A number of endangered and potentially vulnerable species are endemic in this area (World Bank, 1995). Mangroves of the Atlantic coast of Africa including the Niger Delta, on account of their gentle gradient of sediment are sensitive/fragile (Blasco *et al.*, 1996). With the result that minor alteration (natural or anthropogenic) could result in a considerable change in the duration of inundation, thereby causing plant mortality and fauna impact (Figure 3).
